# ENHANCED CONCEPTUAL SITE MODEL FOR THE LOWER BASIN COEUR D'ALENE RIVER

## Technical Memorandum Addendum E-1— Riverbank Characteristics, Erosion Rates, and Lead Contribution

## Riverbank Characteristics, Erosion Rates, and Lead Contribution, Lower Basin of the Coeur d'Alene River (OU3)

PREPARED FOR: U.S. Environmental Protection Agency, Region 10  
PREPARED BY: CH2M HILL  
DATE: December 11, 2015

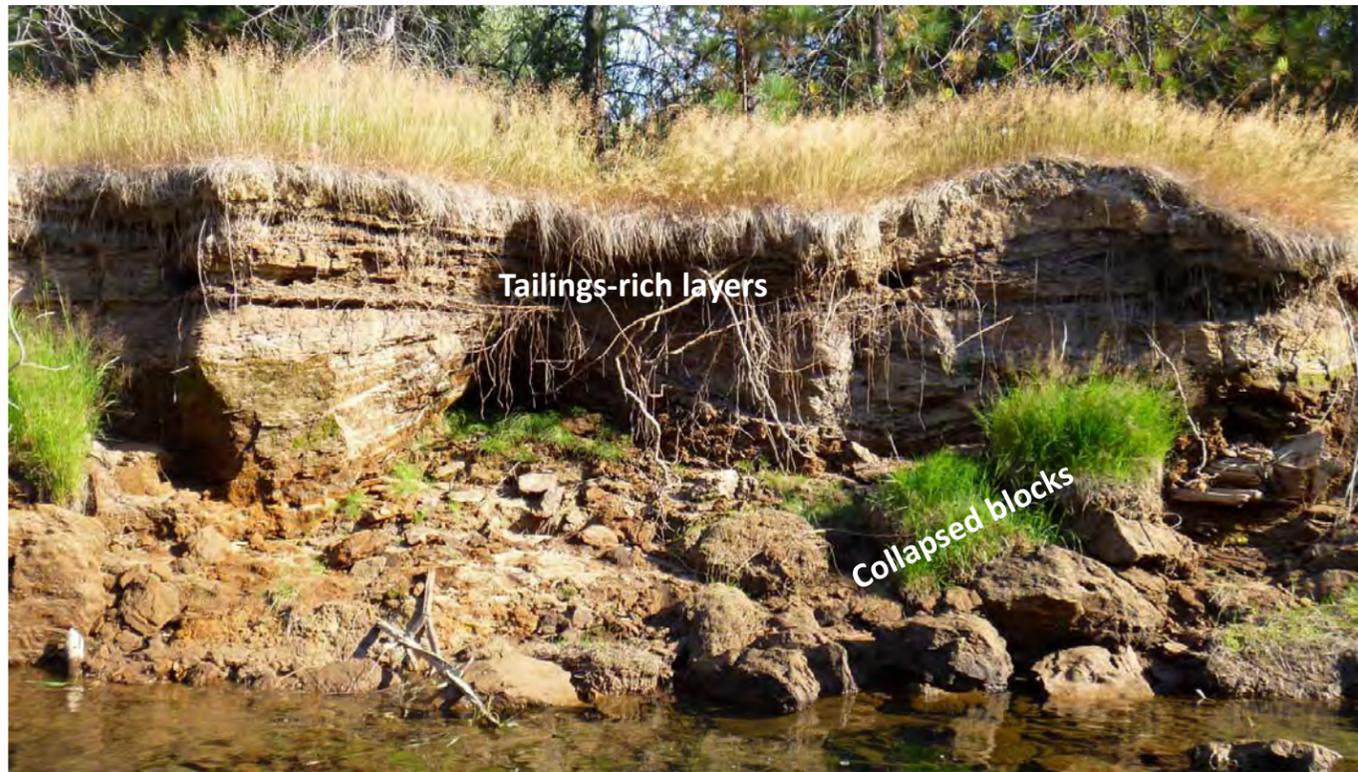
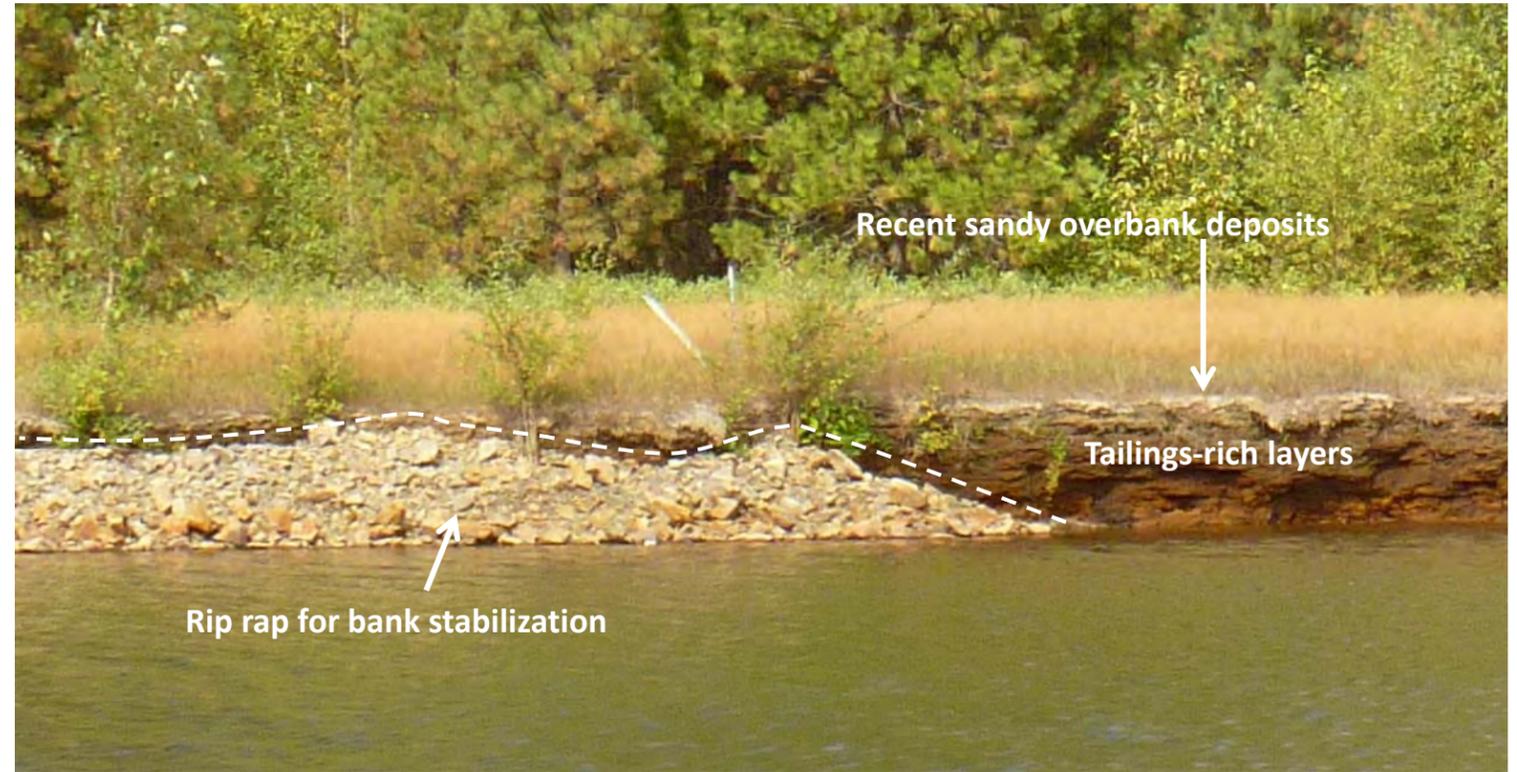
Exhibit 1. Photographs of Bank Features and Characteristics along Lower Coeur d'Alene River  
 River Bank Addendum to Fluvial Geomorphology of the Lower Basin of the Coeur d'Alene River  
 Enhanced Conceptual Site Model (OU3)

Those who live and recreate along the river are familiar with the eroding banks and efforts to stabilize eroding banks with rock, vegetation, and other materials, as shown in Exhibit 1. Bank erosion is a natural process in most river systems; however, local conditions can exacerbate the rate of bank erosion. Exhibit 3 illustrates the current conceptual model of the cyclical process of bank erosion, which is accelerated in the absence of a deep-binding root mass of vegetation or armoring. In addition to seasonal high river flows, hydraulic forces resulting from wind waves and boat wakes can contribute to bank undercutting.

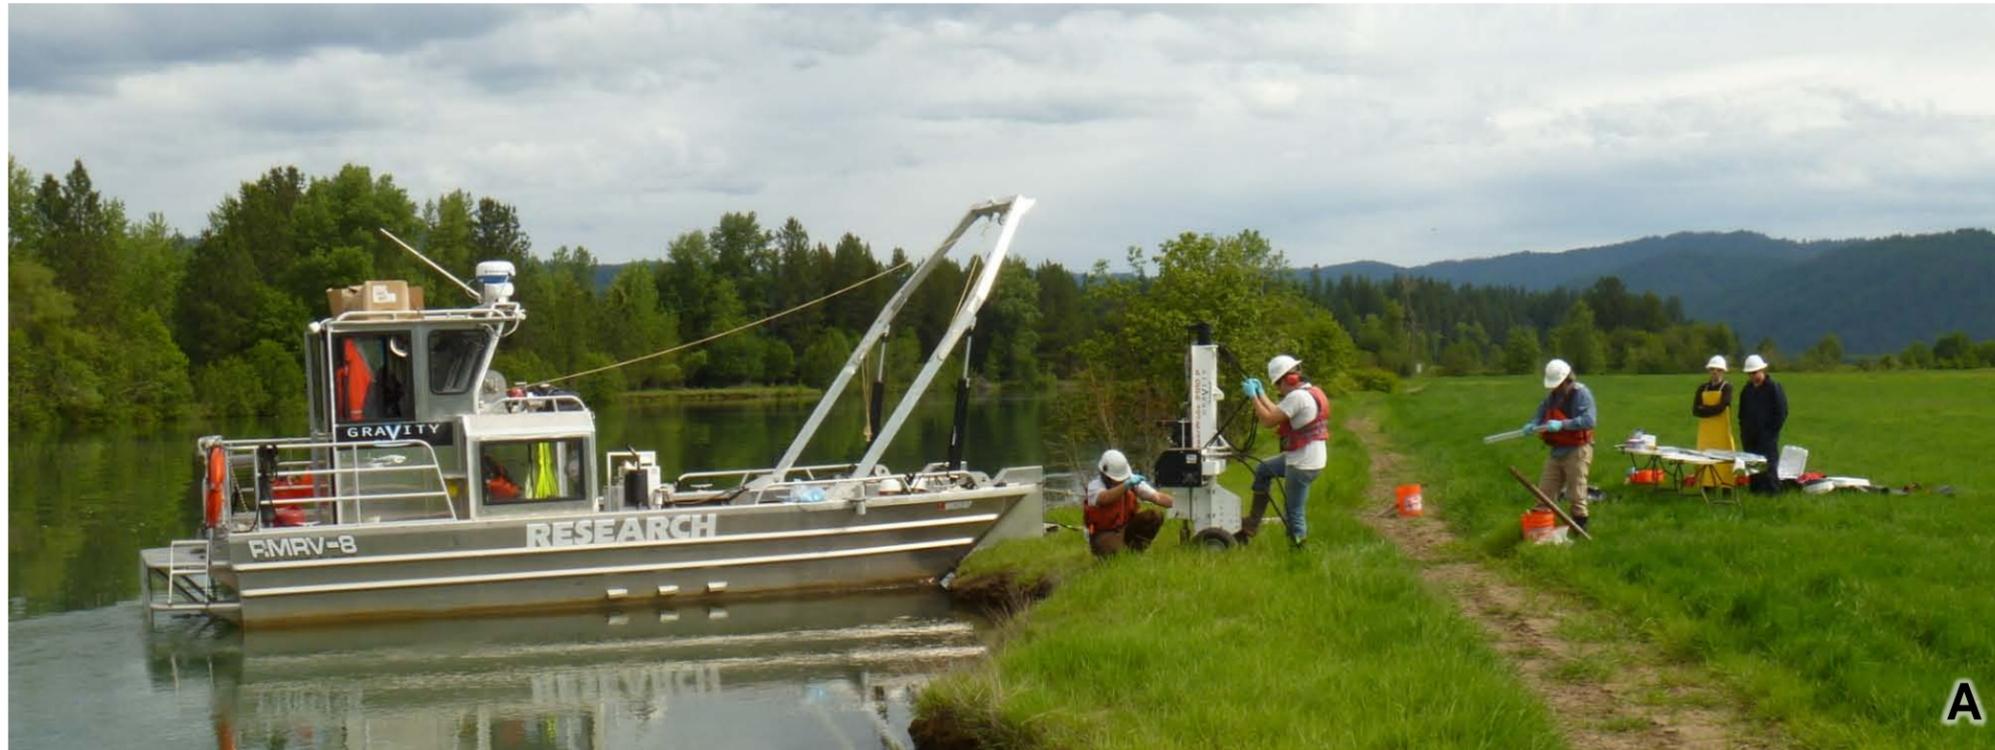
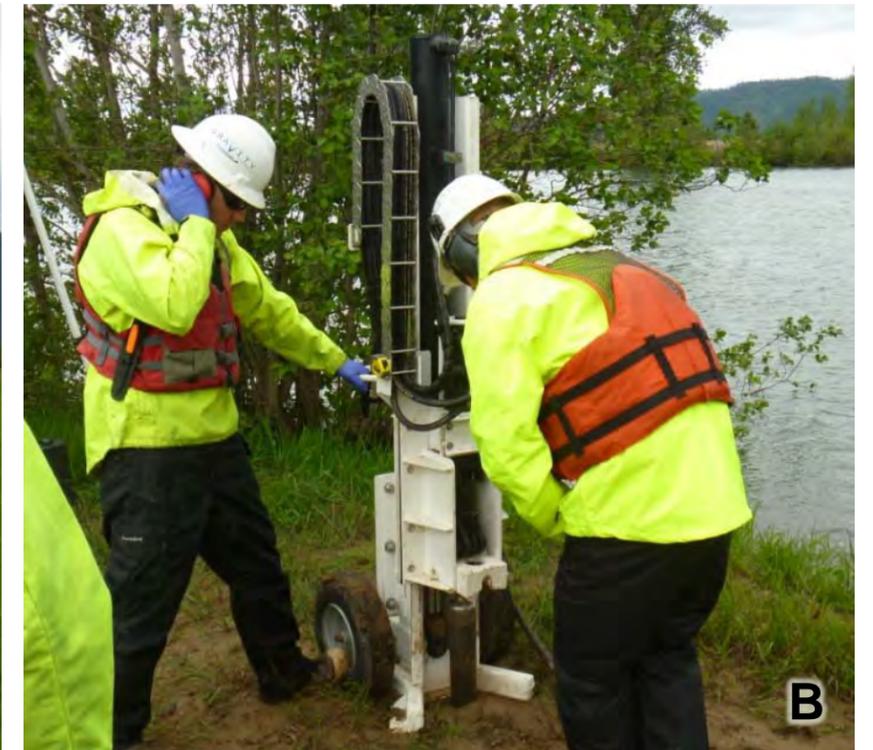
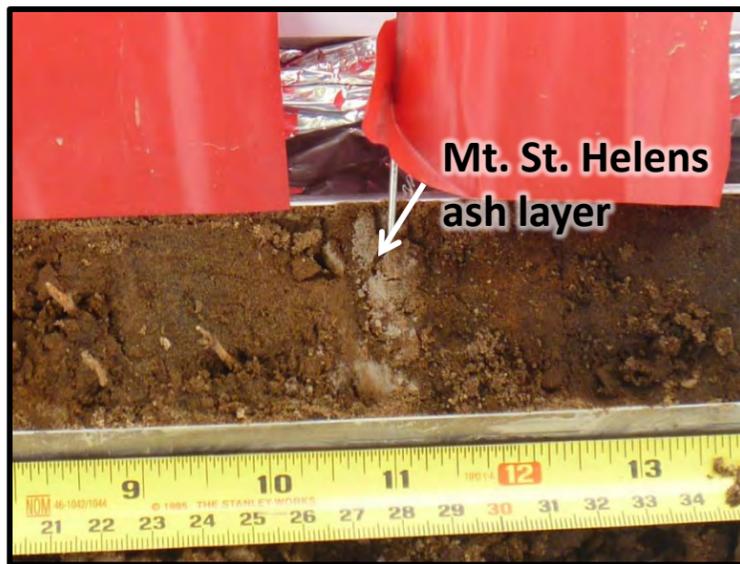
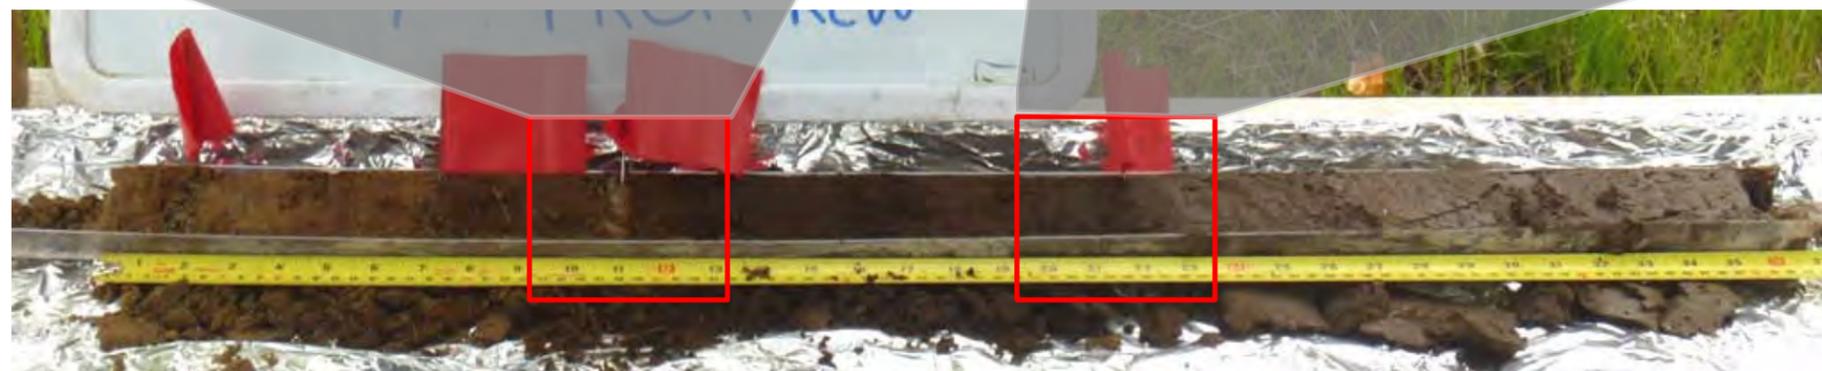
Strobl Transect- RM 147.7 – Right bank

Notes:  
 Photograph A shows bank coring set up with geoprobe transported by boat to coring locations. The core processing station is shown to the right where field XRF readings and characterization of the cores was performed.  
 Photograph B shows geoprobe rig used for bank coring.  
 Photograph C shows a representative core from the right bank of the Strobl transect at river mile (RM) 147.7. The core is aligned with the top (ground surface end) of the core at the left end of the photograph. The callout photographs illustrate the Mt. St. Helens ash layer in the upper part of the core and the horizon between mining-impacted sediments and pre-mining sediments.

Exhibit 6. **Bank Coring Photographs**  
 Riverbank Characteristics, Erosion Rates, and Lead Contribution  
 Lower Basin Coeur d'Alene River (OU3)

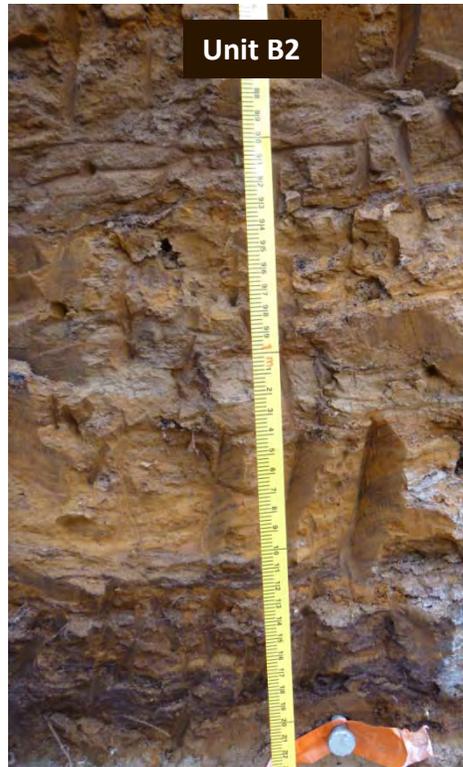
**Exhibit 7. Characteristic Bank Stratigraphy**  
 Riverbank Characteristics, Erosion Rates, and Lead Contribution  
 Lower Basin Coeur d'Alene River (OU3)

Repeated observations of the stratigraphy in exposed riverbank faces indicate that the units observed in riverbanks are consistently definable throughout the Lower Basin (Exhibit 7).

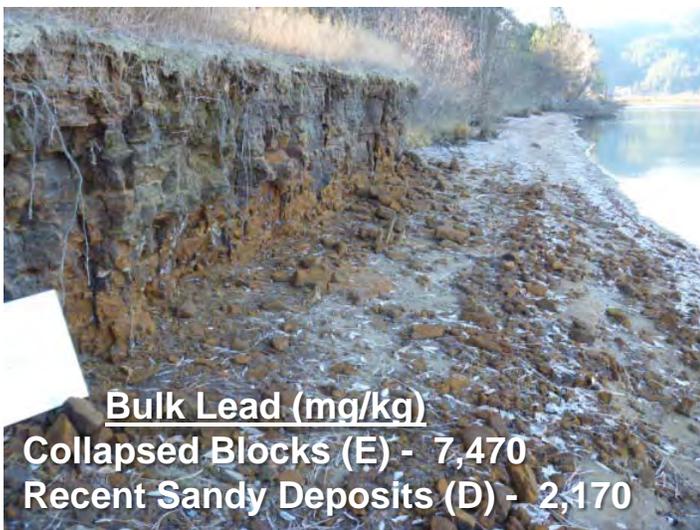
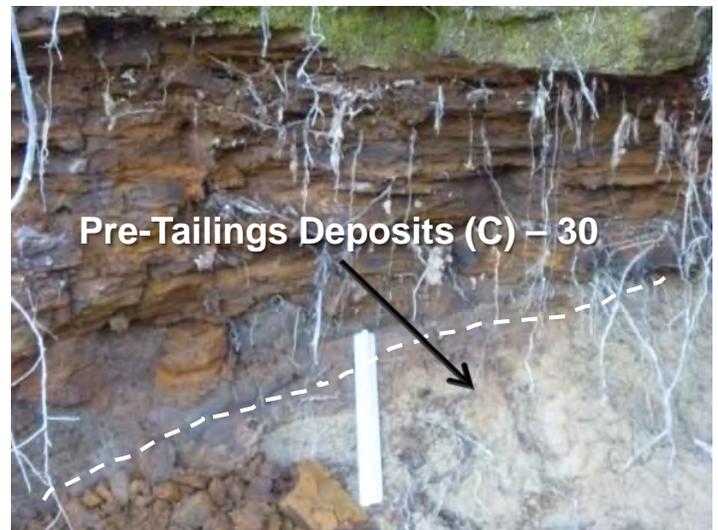
Exhibit 9. Example Bank Sampling Results of Lead Content by Stratigraphic Layer  
Riverbank Characteristics, Erosion Rates, and Lead Contribution  
Lower Basin Coeur d'Alene River (OU3)

## RM 144.1L (Fine Scale Sampling)

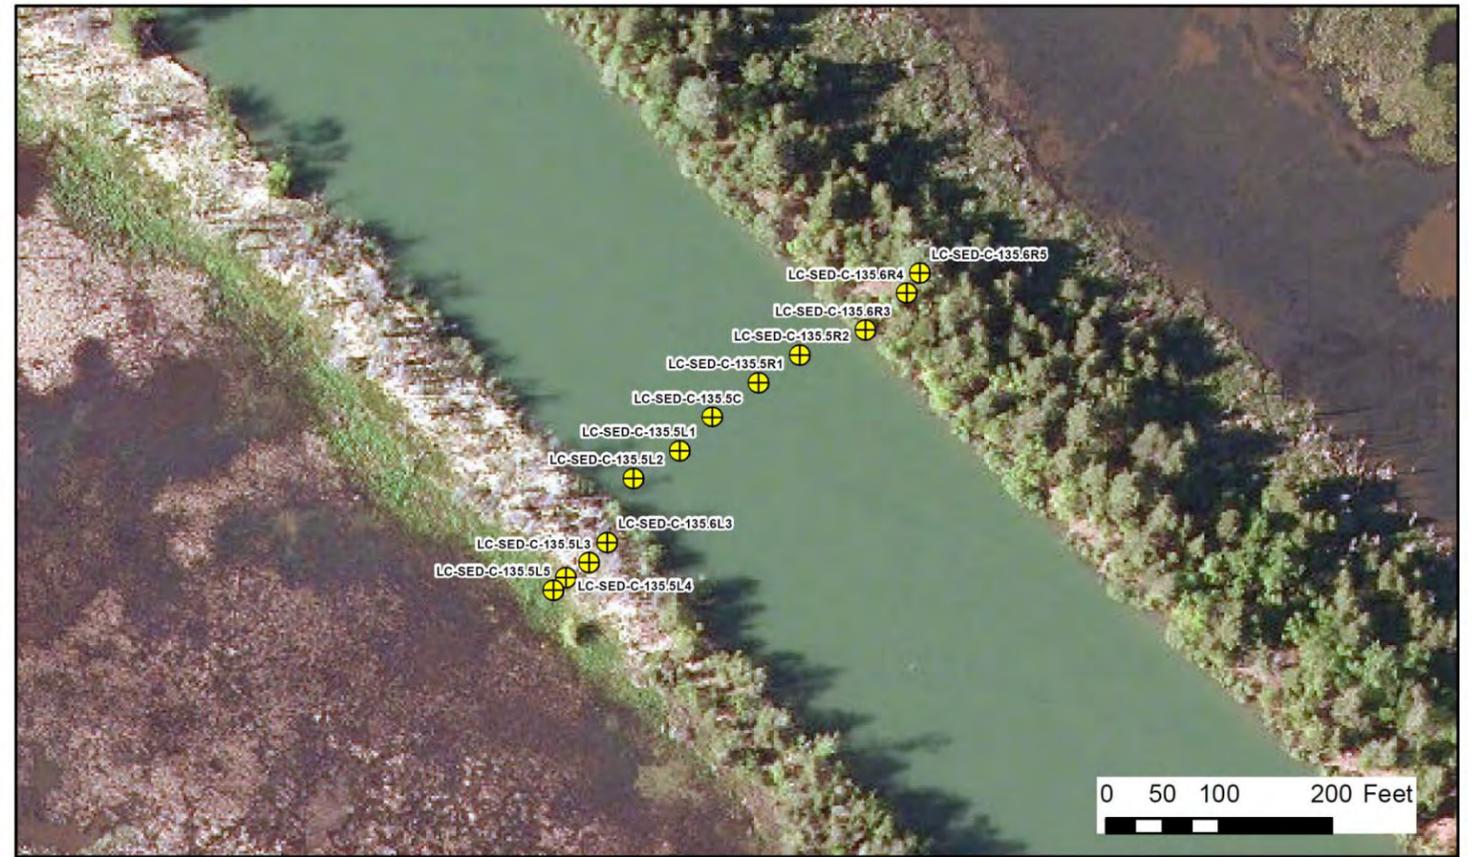
Sample Names:  
 LC = Lower Coeur d'Alene  
 SED = sediment  
 C = Subsurface Core Study  
 ###.# = river mile location rounded to the nearest one tenth of a mile  
 L, R, DN, UP, and C = left, right, downstream, upstream, and center

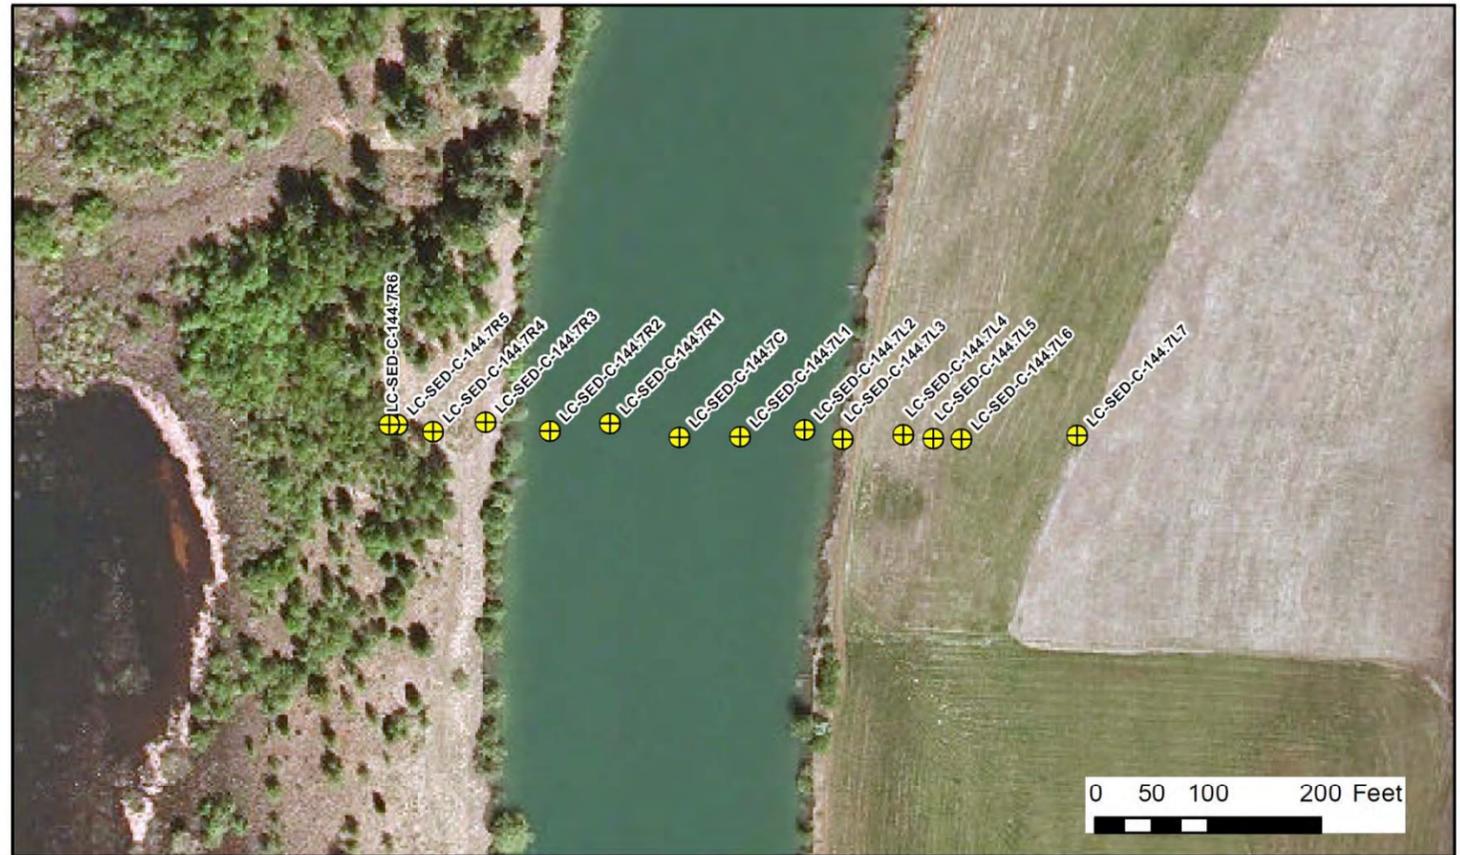
Exhibit 14A (Sheet 2). **Transect of Riverbed and Bank Cores Coded by Bulk Lead Content, Springston Location**  
Riverbank Characteristics, Erosion Rates, and Lead Contribution  
Lower Basin Couer d'Alene River (OU3)

Sample Names:  
 LC = Lower Coeur d'Alene  
 SED = sediment  
 C = Subsurface Core Study  
 ###.# = river mile location rounded to the nearest one tenth of a mile  
 L, R, DN, UP, and C = left, right, downstream, upstream, and center

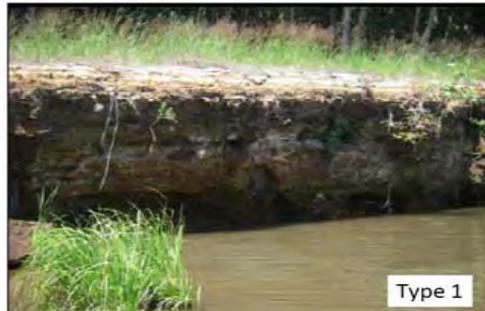
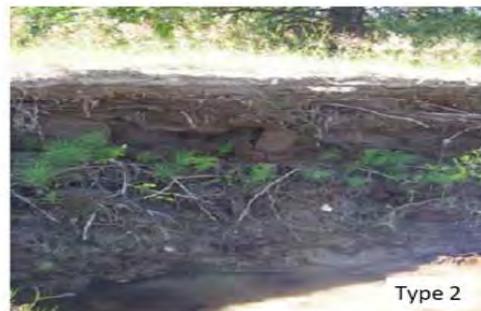
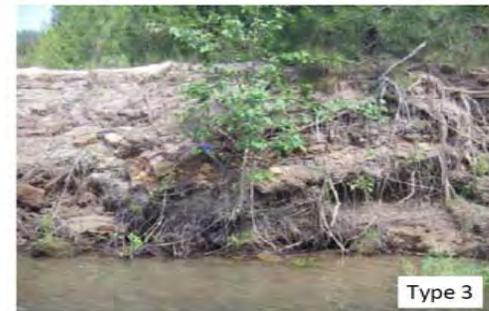
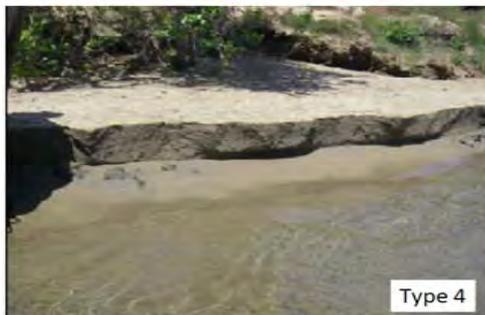
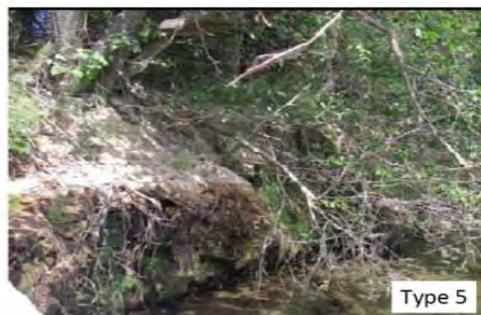
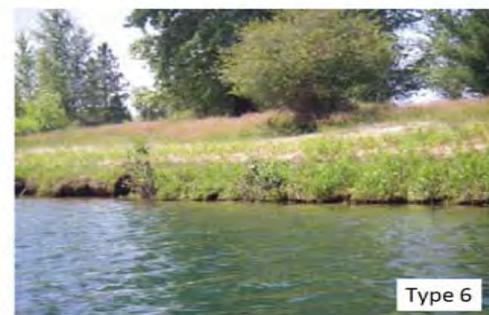
Exhibit 17. **Bank Types in Kootenai-Shoshone Soil and Water Conservation District Bank Pin Monitoring**  
Riverbank Characteristics, Erosion Rates, and Lead Contribution  
Lower Basin Coeur d'Alene River (OU3)

Photographs of representative bank types are shown below.
