St. Maries Creosote Site Remediation Summary

Basin Environmental Improvement Project Commission

August 15, 2018

U.S. EPA, Region 10, Hanford Project Office

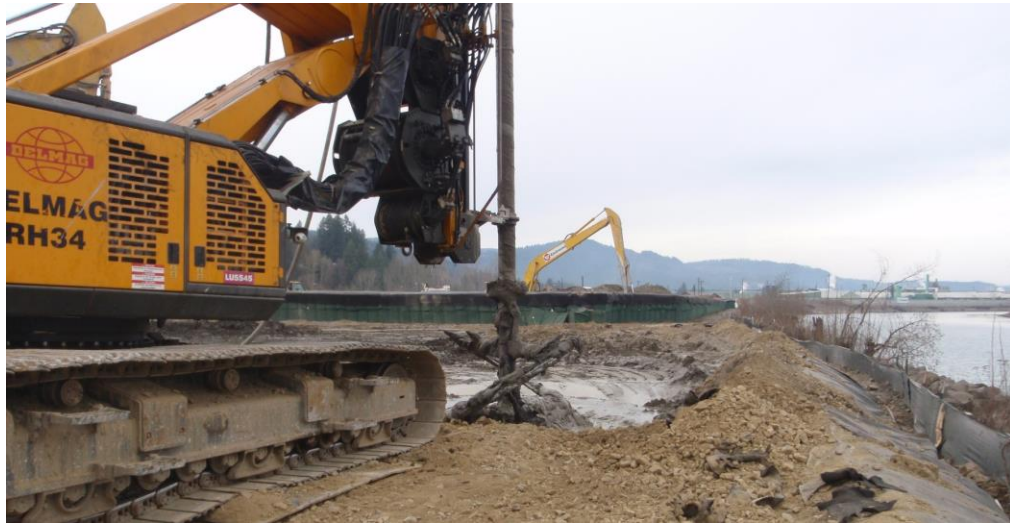
Column mixing using augur for ISS

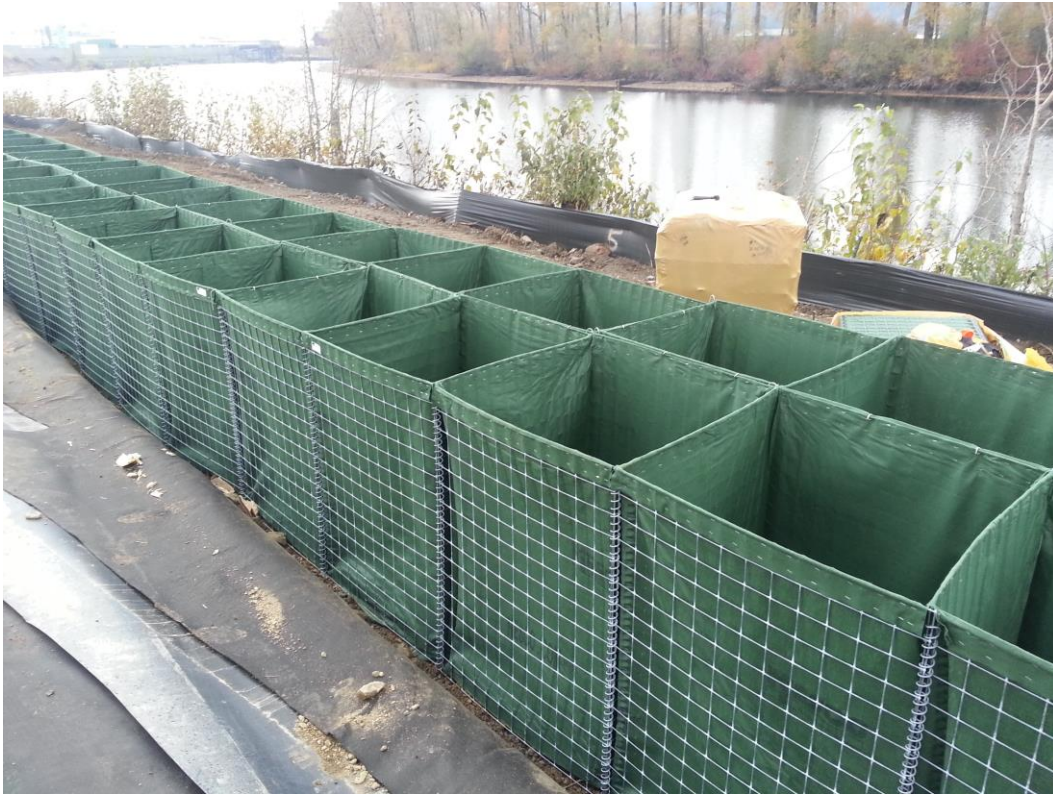
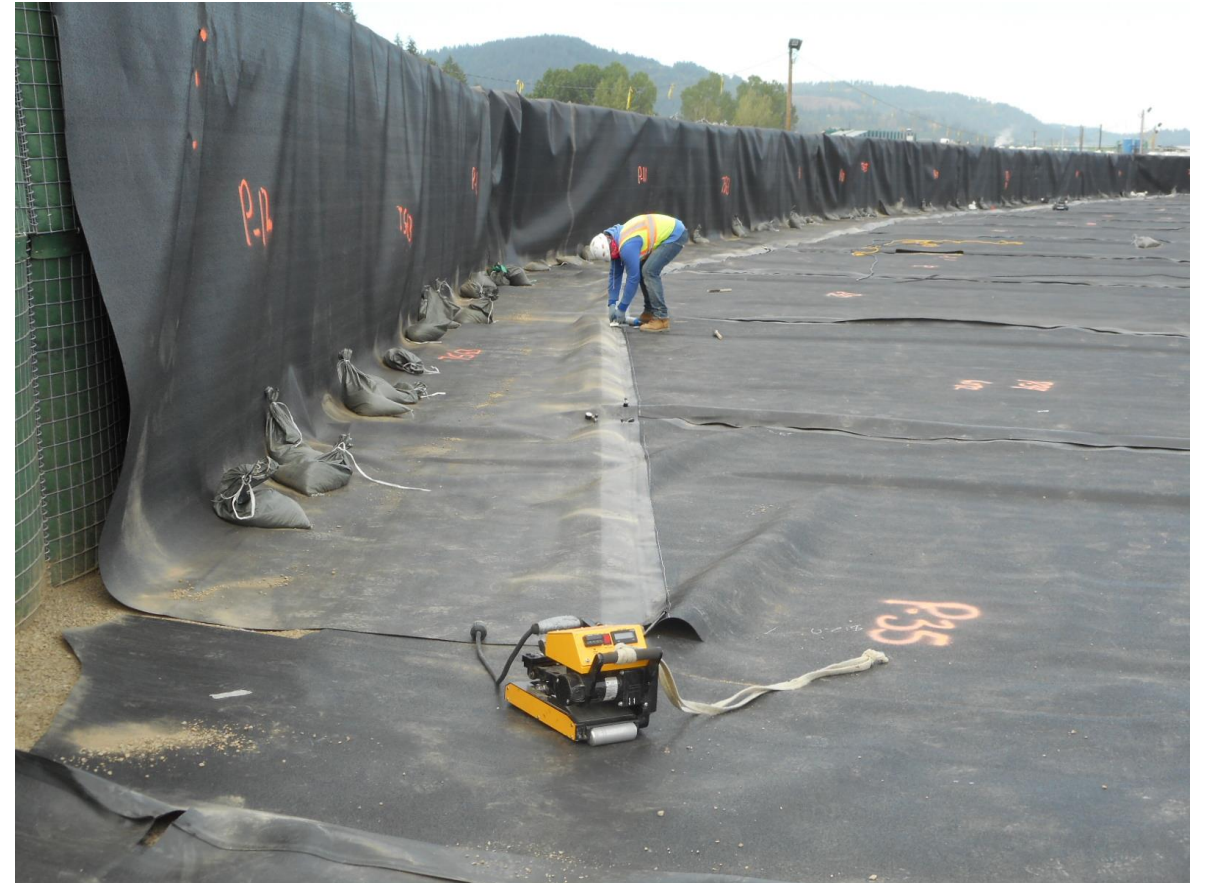
Construct Dewatering Pad

Hesco bags set at 8 ft tall to protect against flooding, based on modeling

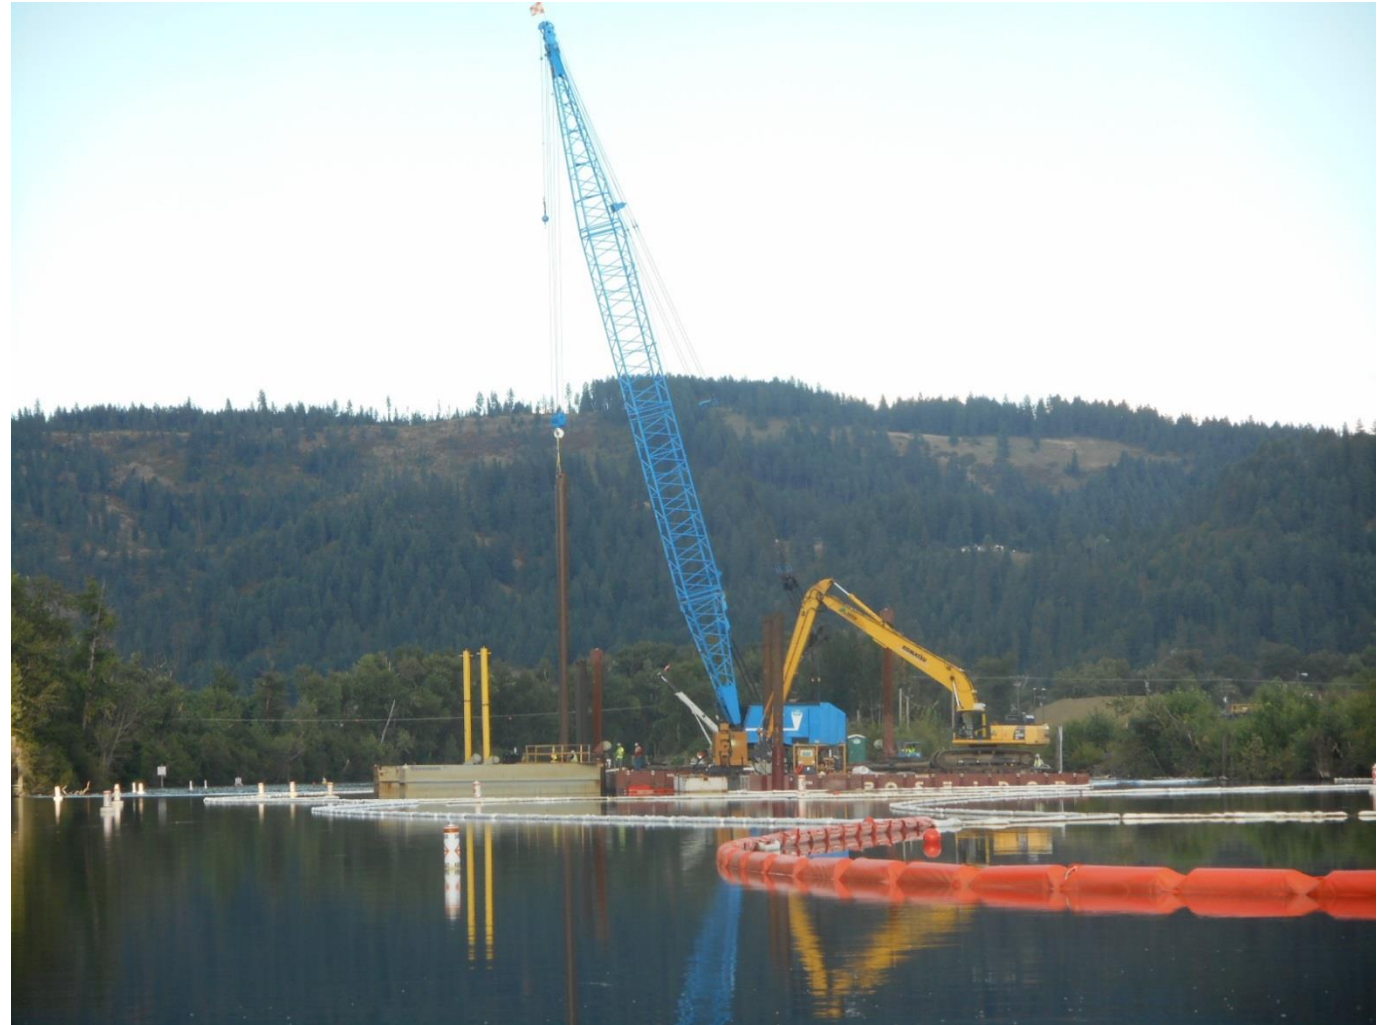
Prepping for In-Water Work (June 2015)

- Installed aids to navigation for a no-wake zone
- Install sheet pile wall
- Resuspension Control System installed downstream of dredge units
 - Oil Boom
 - Sorbent Boom
 - Silt Curtain

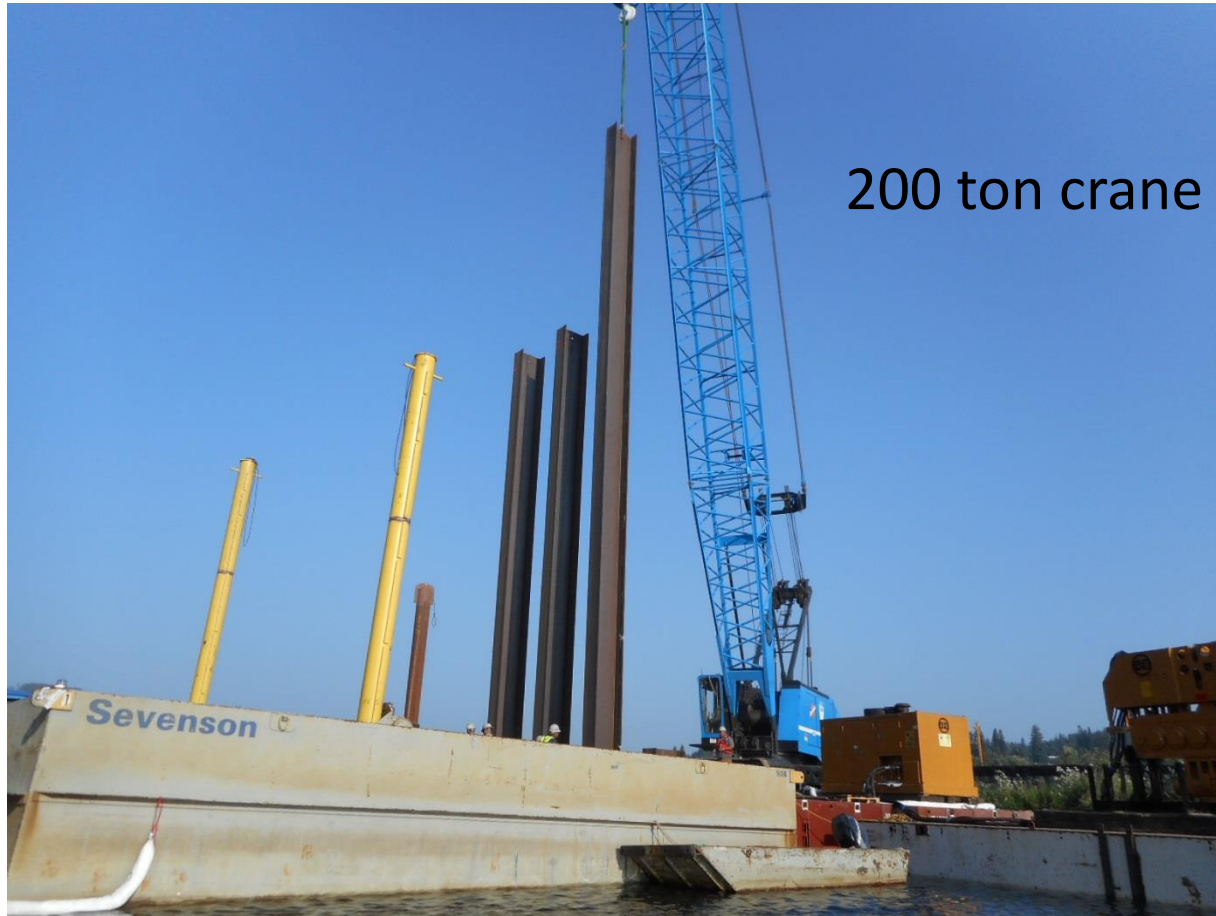
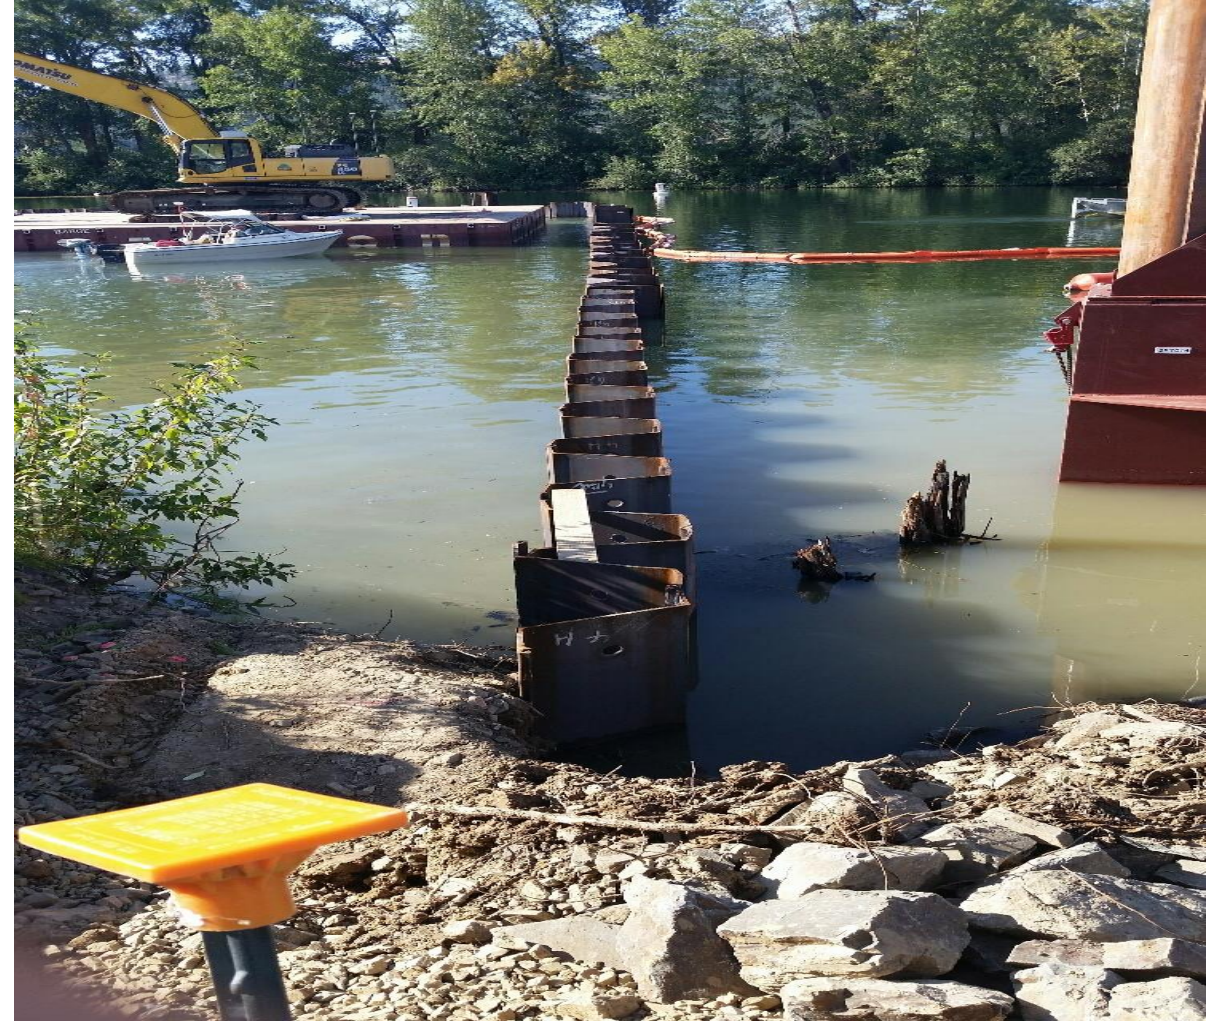
Sheetpile Wall

- Vibratory hammer to protect Bull Trout
- Enclosure set up was a combination wall consisting of an alternating sequence of H-Pile (King Pile) and sheetpile.
- Sealant was applied to the joints just prior to installation to provide a water-tight seal.

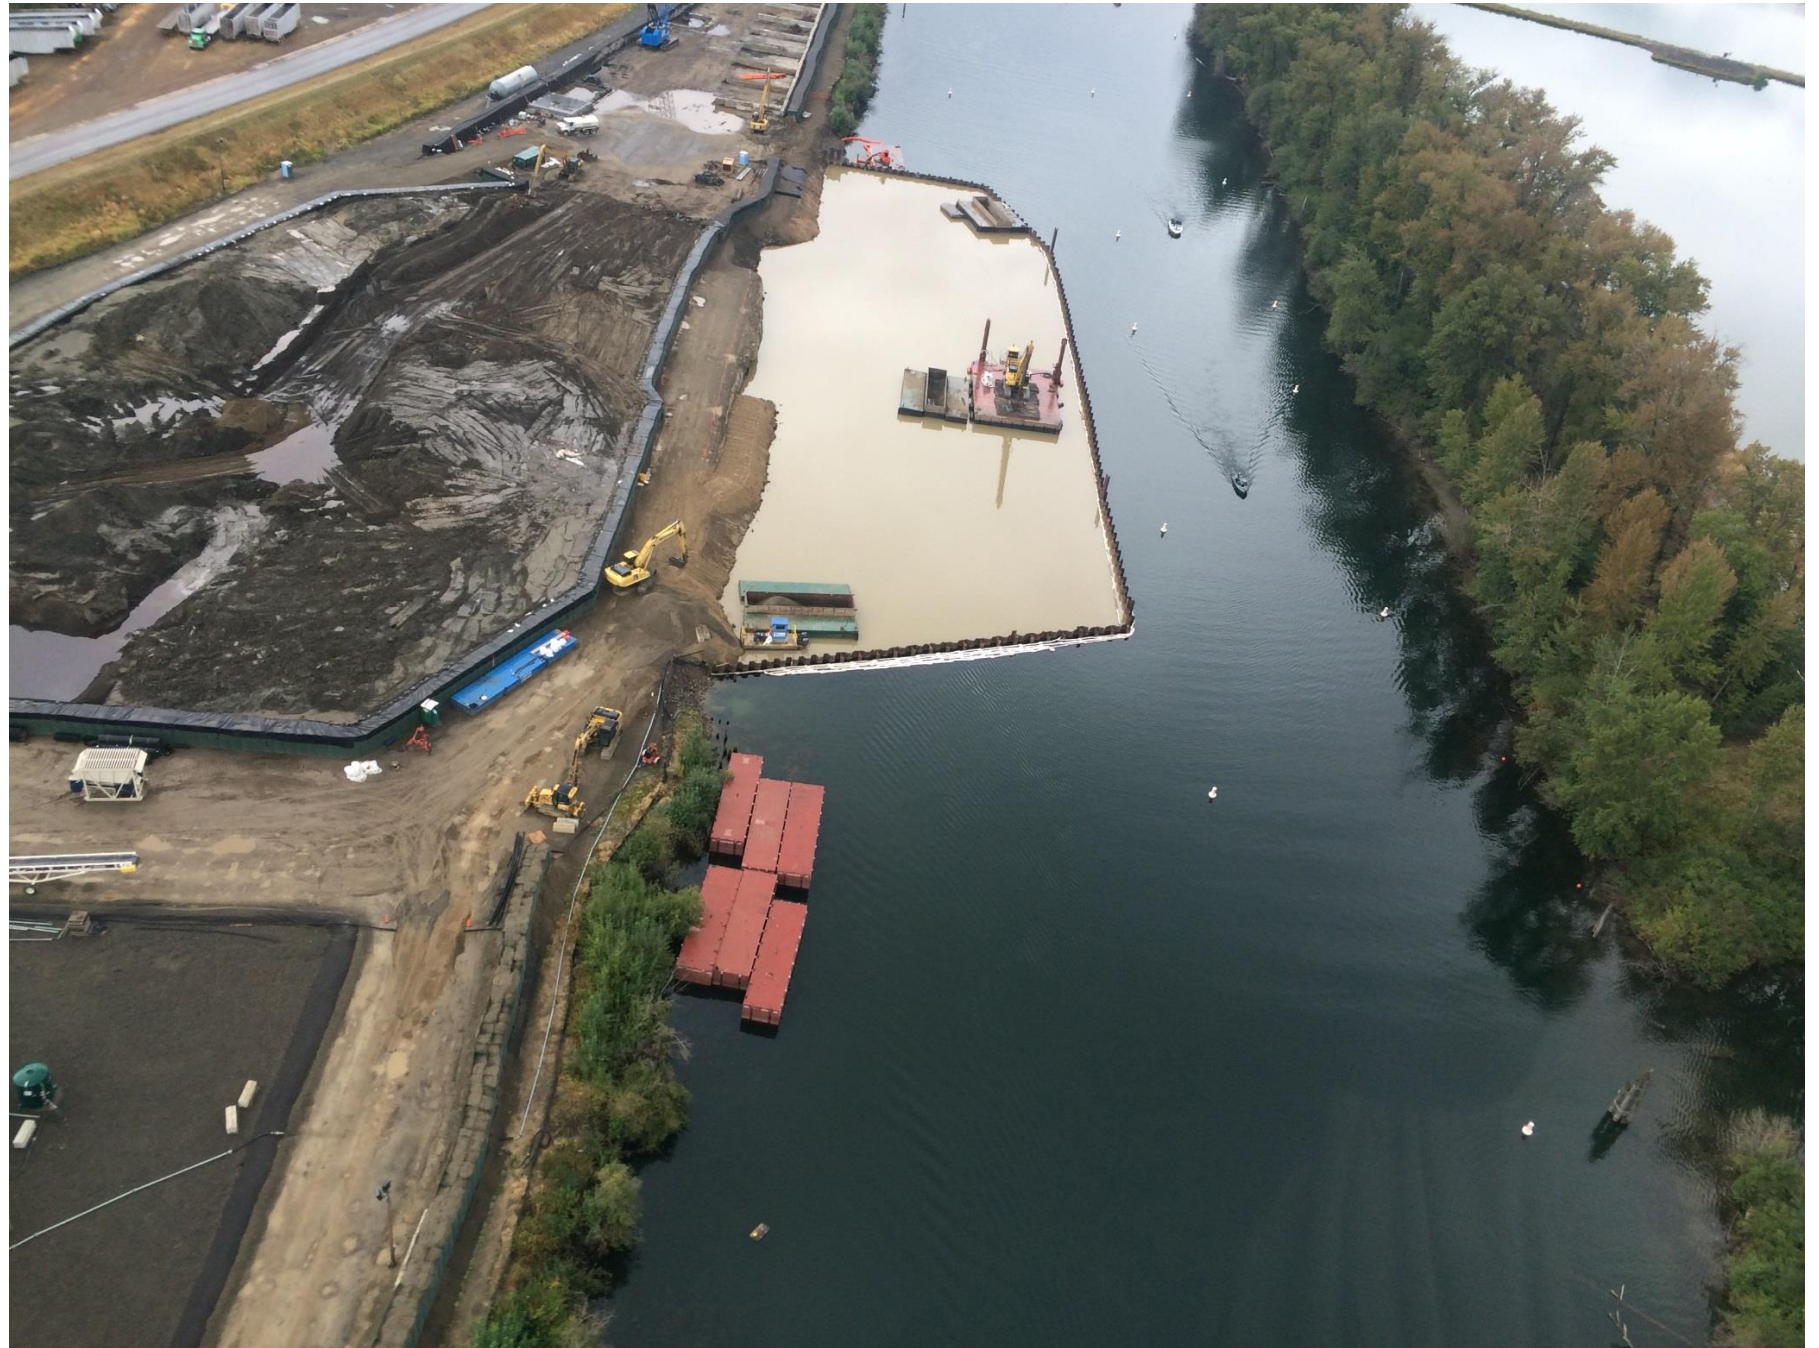
Sheetpile Effectiveness

Stockpiled clean
sediment for
backfill

Wastewater
Treatment
Plant

Stockpiles sediments

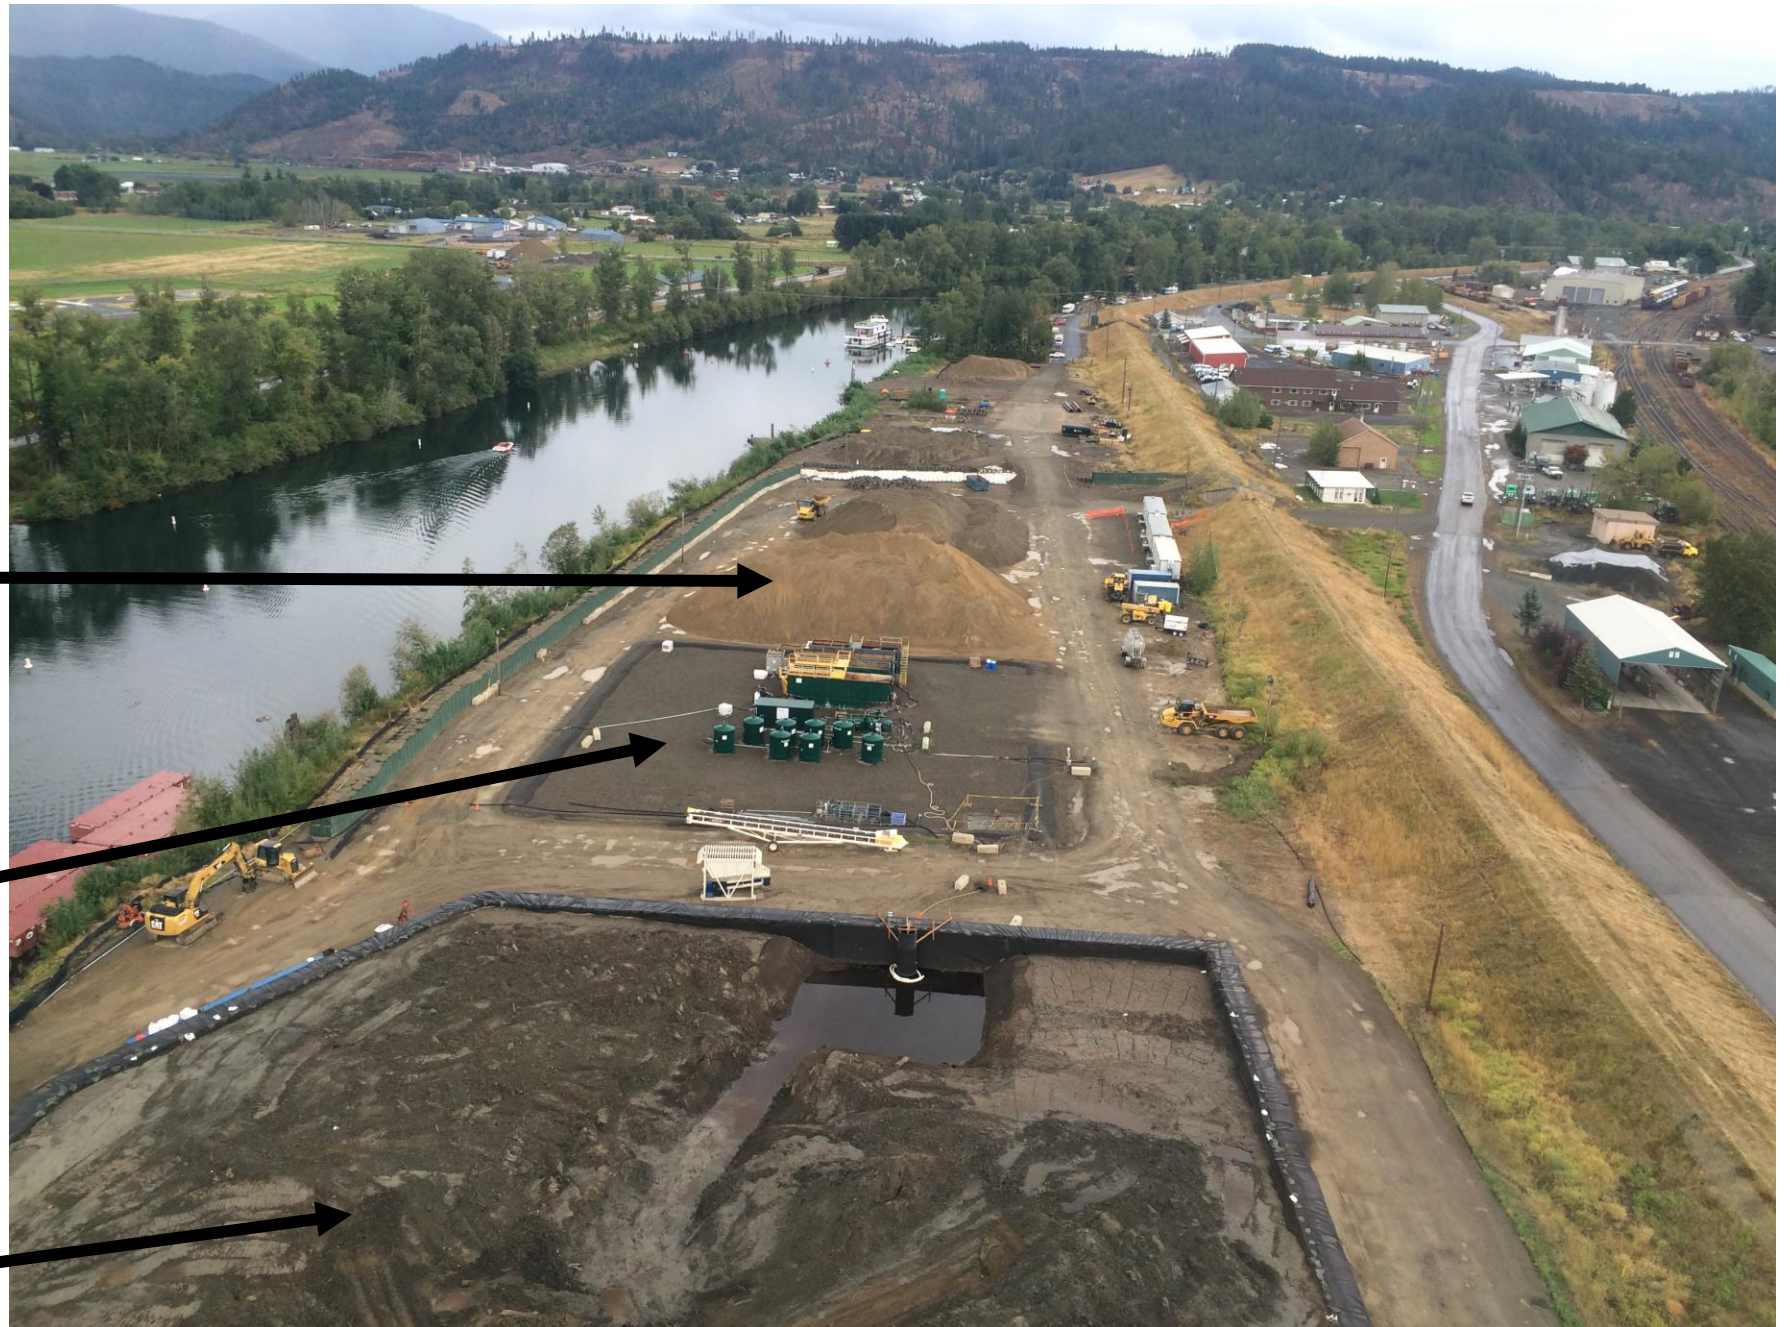
Backfilling Progress Figure

Today		Total	
Backfill Units	Approx. Volume Placed	Completed Backfill Units	Approx. Volume Placed To-date
DU-11	1500 CY	—	16,590 CY

Backfilled to 6 ft below final grade
-

Backfilling in process

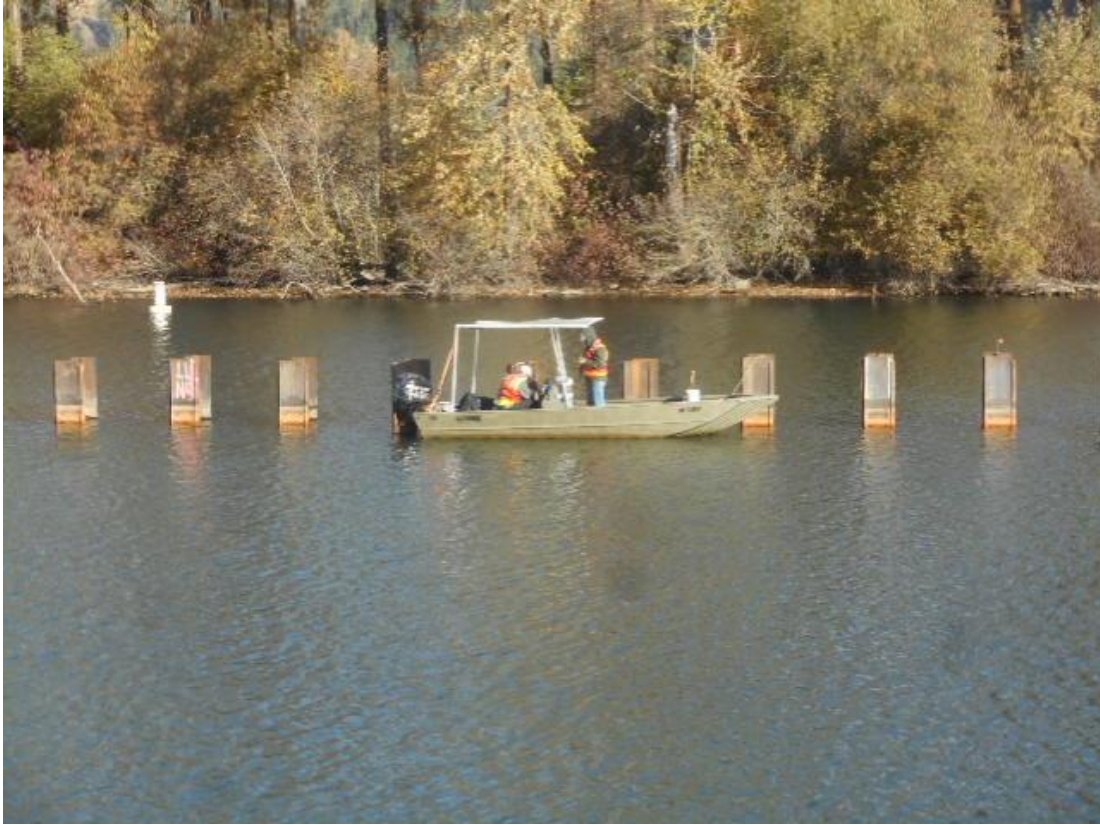
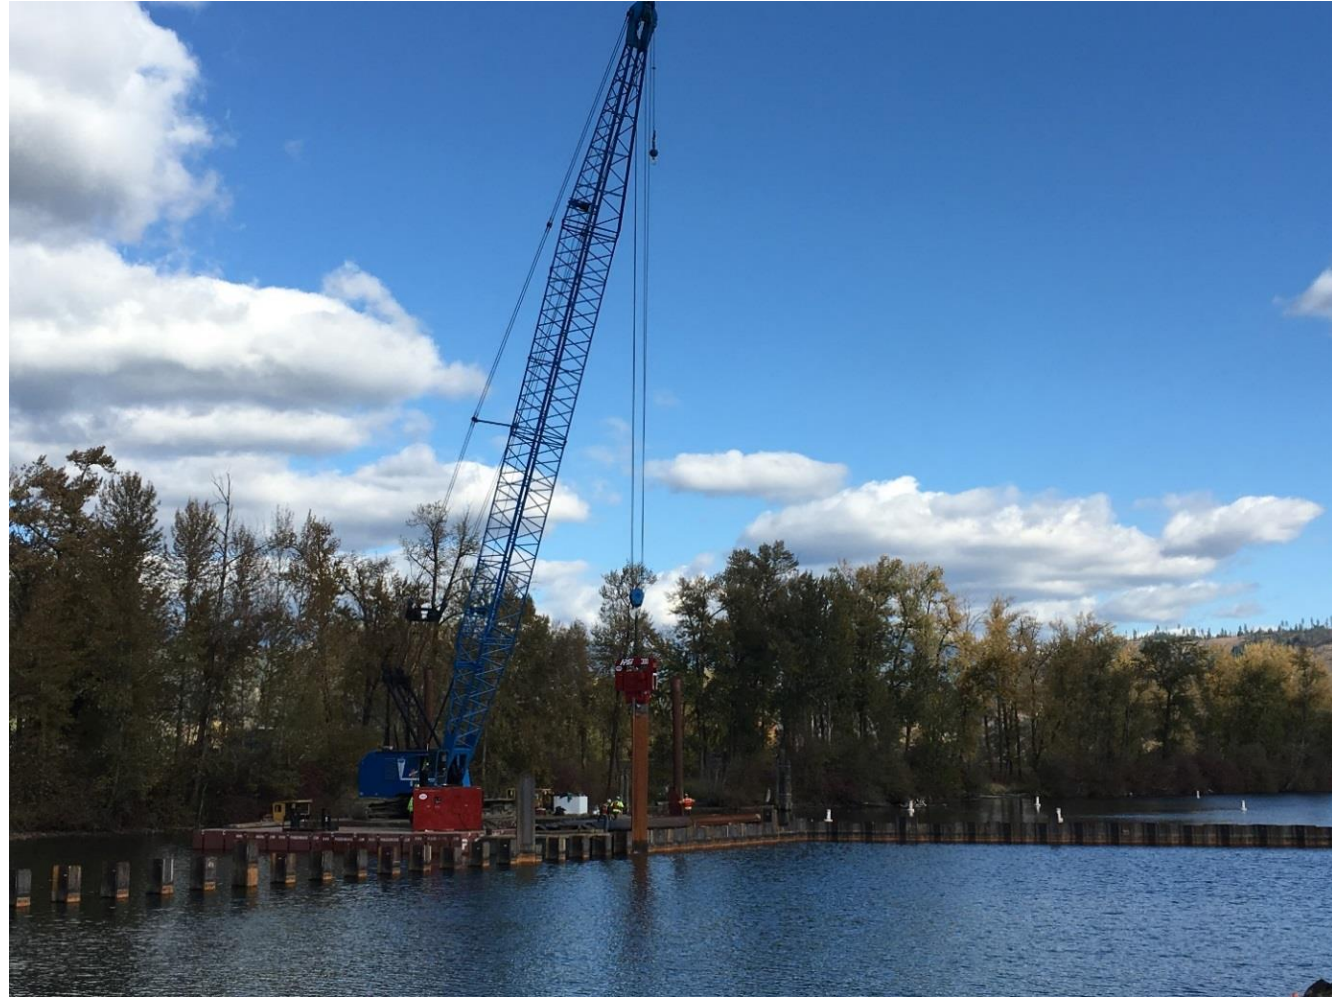
Sheet Pile Removal

- NTU readings in the enclosure were over 1000 NTUs once backfilling was complete.
- After 2 week setting time period, turbidity came down to 132 NTUs.
- Limited water quality exceedances alarms during enclosure removal

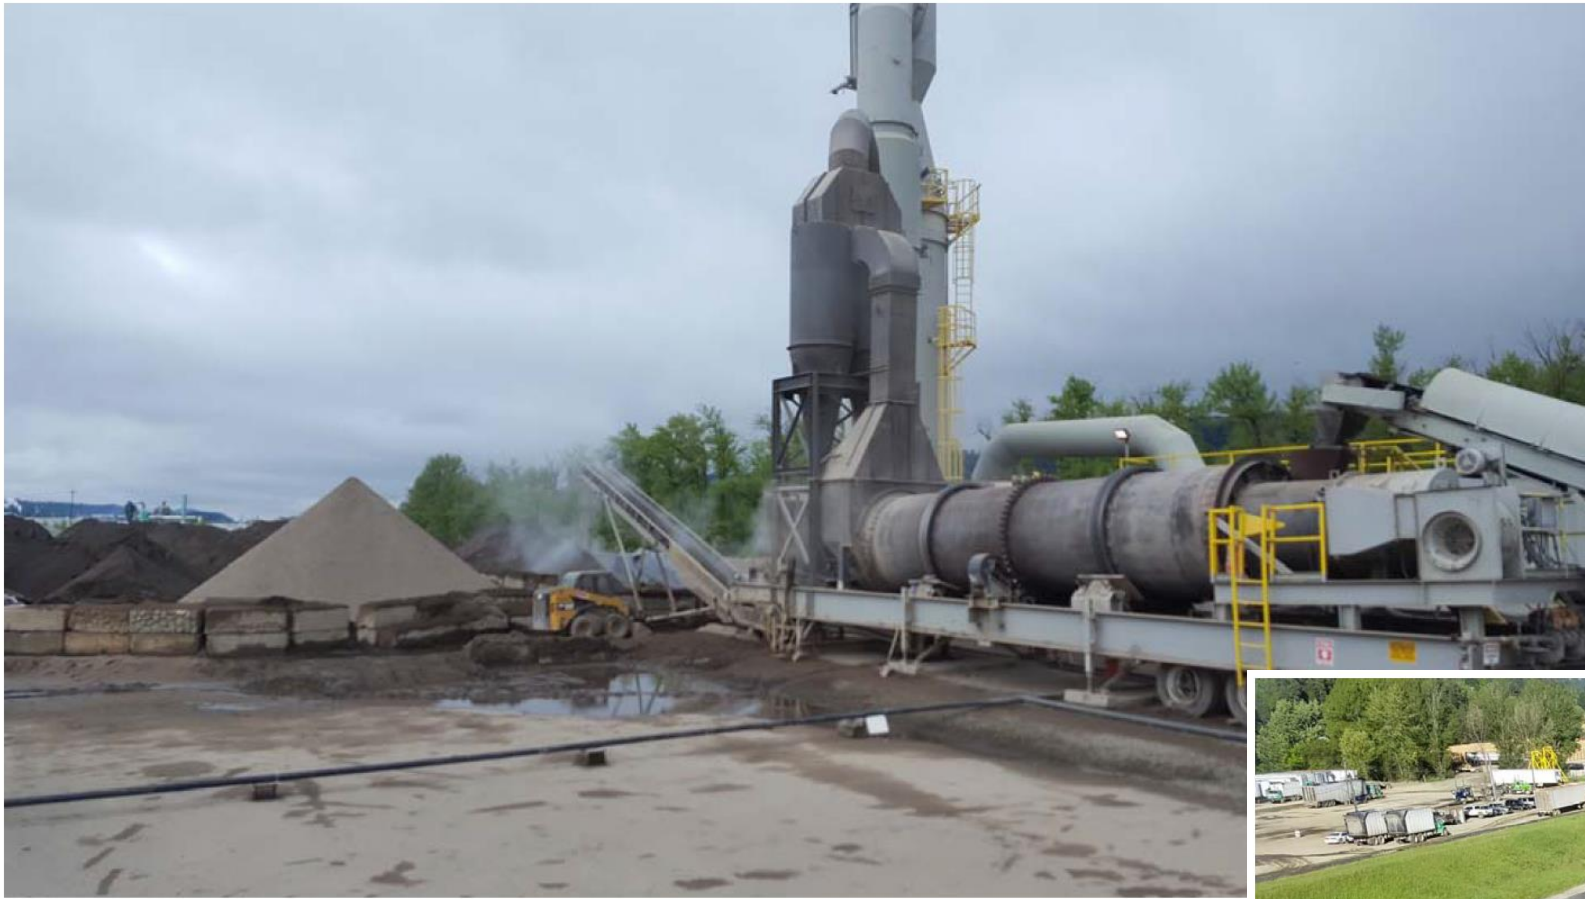
Thermal Desorption Unit

- 900-950° F
- 45,000 tons of soil treated

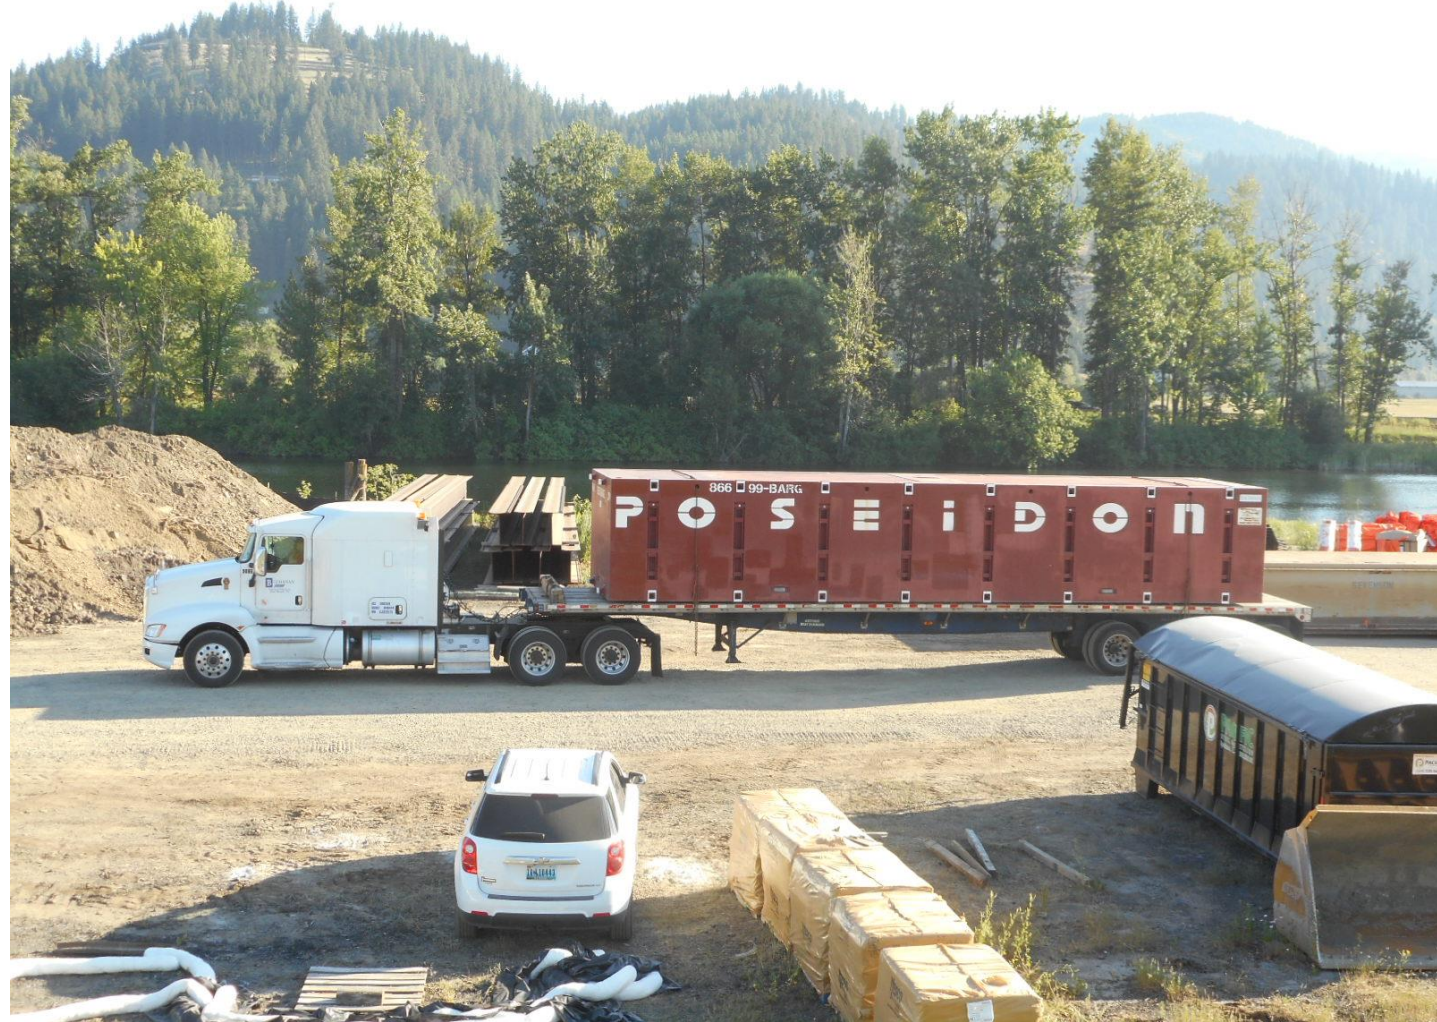
Barge Delivery (June 2015)

- 200-ton cranes used to place barges in river
- Idaho State Dept. of Agriculture inspected the received barges for invasive species
 - 4 of the Sunflower barges were identified as having dead zebra mussels attached.
